A Building Renewal Case Study

September 17, 2019

THE UNIVERSITY OF ARIZONA BUILDING 90

THE UNIVERSITY OF ARIZONA BUILDING 90 DEFERRED MAINTENANCE IMPROVEMENTS

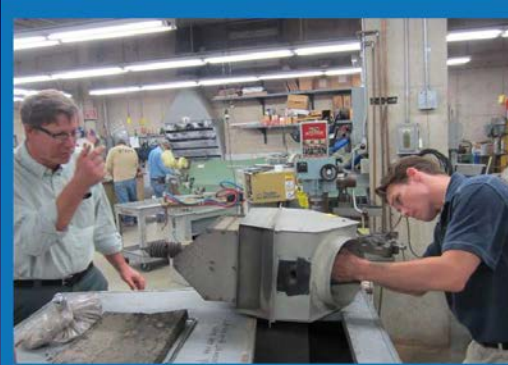
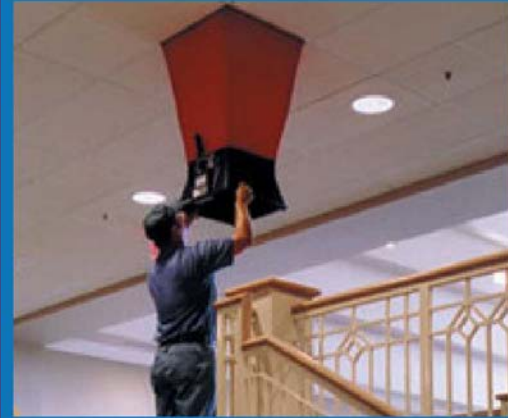
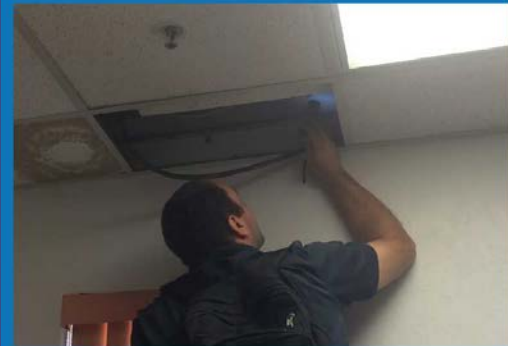
- Assemble Project Task Force Team
- Weekly meetings / Interview occupants
- Coordinate and work with building manager
- Room-by-Room Architect / Engineer survey
- Airflow Testing
- Fire Safety / Emergency Egress assessment
- Structural assessment

- Building Envelope / Evaluation of Water Infiltration
- Above-Ceiling survey
- Camera Survey of HVAC systems
- Terminal Unit dissection
- Ventilation assessment
- Laboratory Testing of Contaminants (CO, CO₂, SO₂, mold spores, airborne debris)
- Energy Savings

- Cracked concrete floors
- Antiquated cold rooms
- Envelope leakage
- Asbestos fireproofing
- Deteriorated insulation
- Duct leakage
- Constant volume air handlers
- Inefficient lab exhaust
- No energy recovery
- Low air changes
- Dirty ductwork
- Interior duct lining
- Exterior standing water
- Grading / site drainage issues
- Piping dead legs
- Industrial Hygienist results

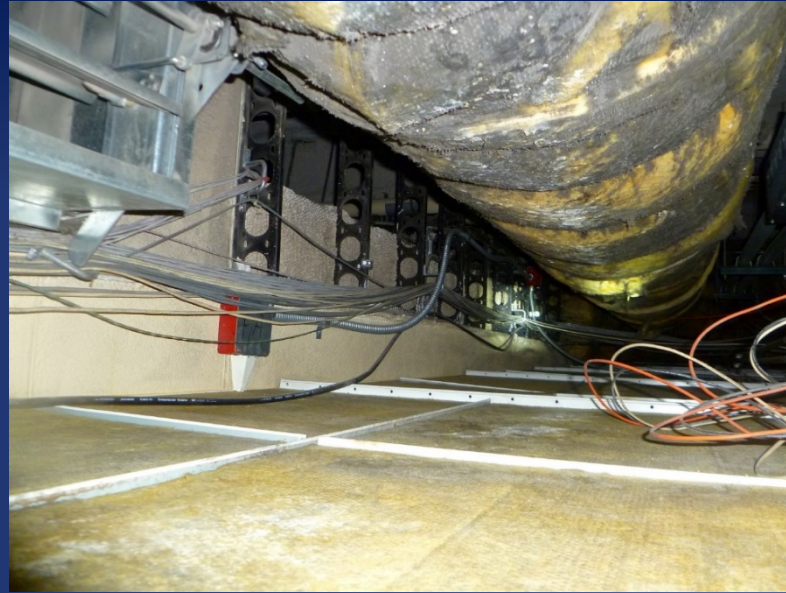
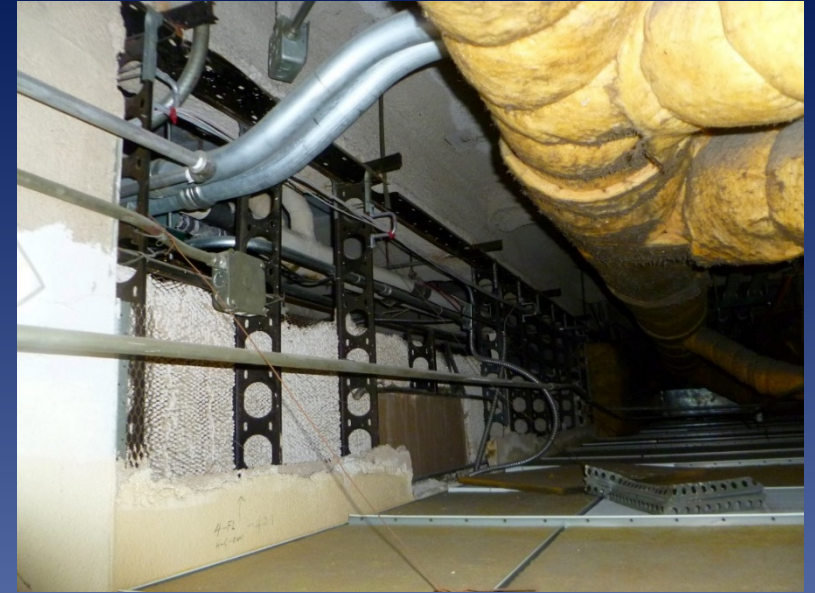
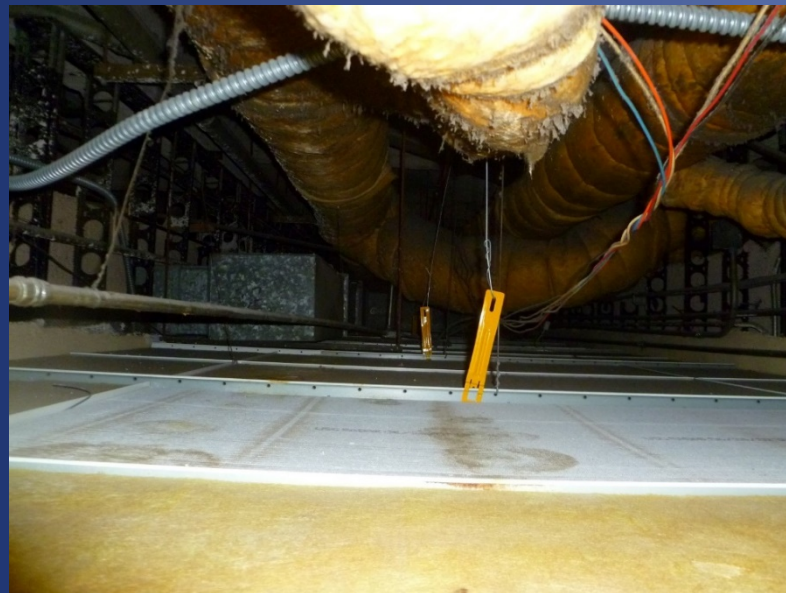
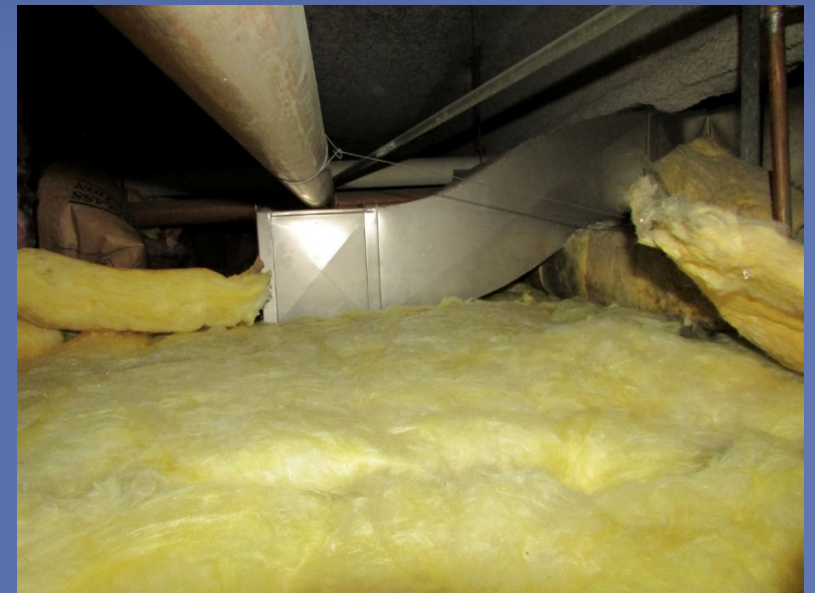
ABOVE CEILING BEFORE

Filthy Duct
Failing Insulation
Leaking Pipe
Asbestos
Mold

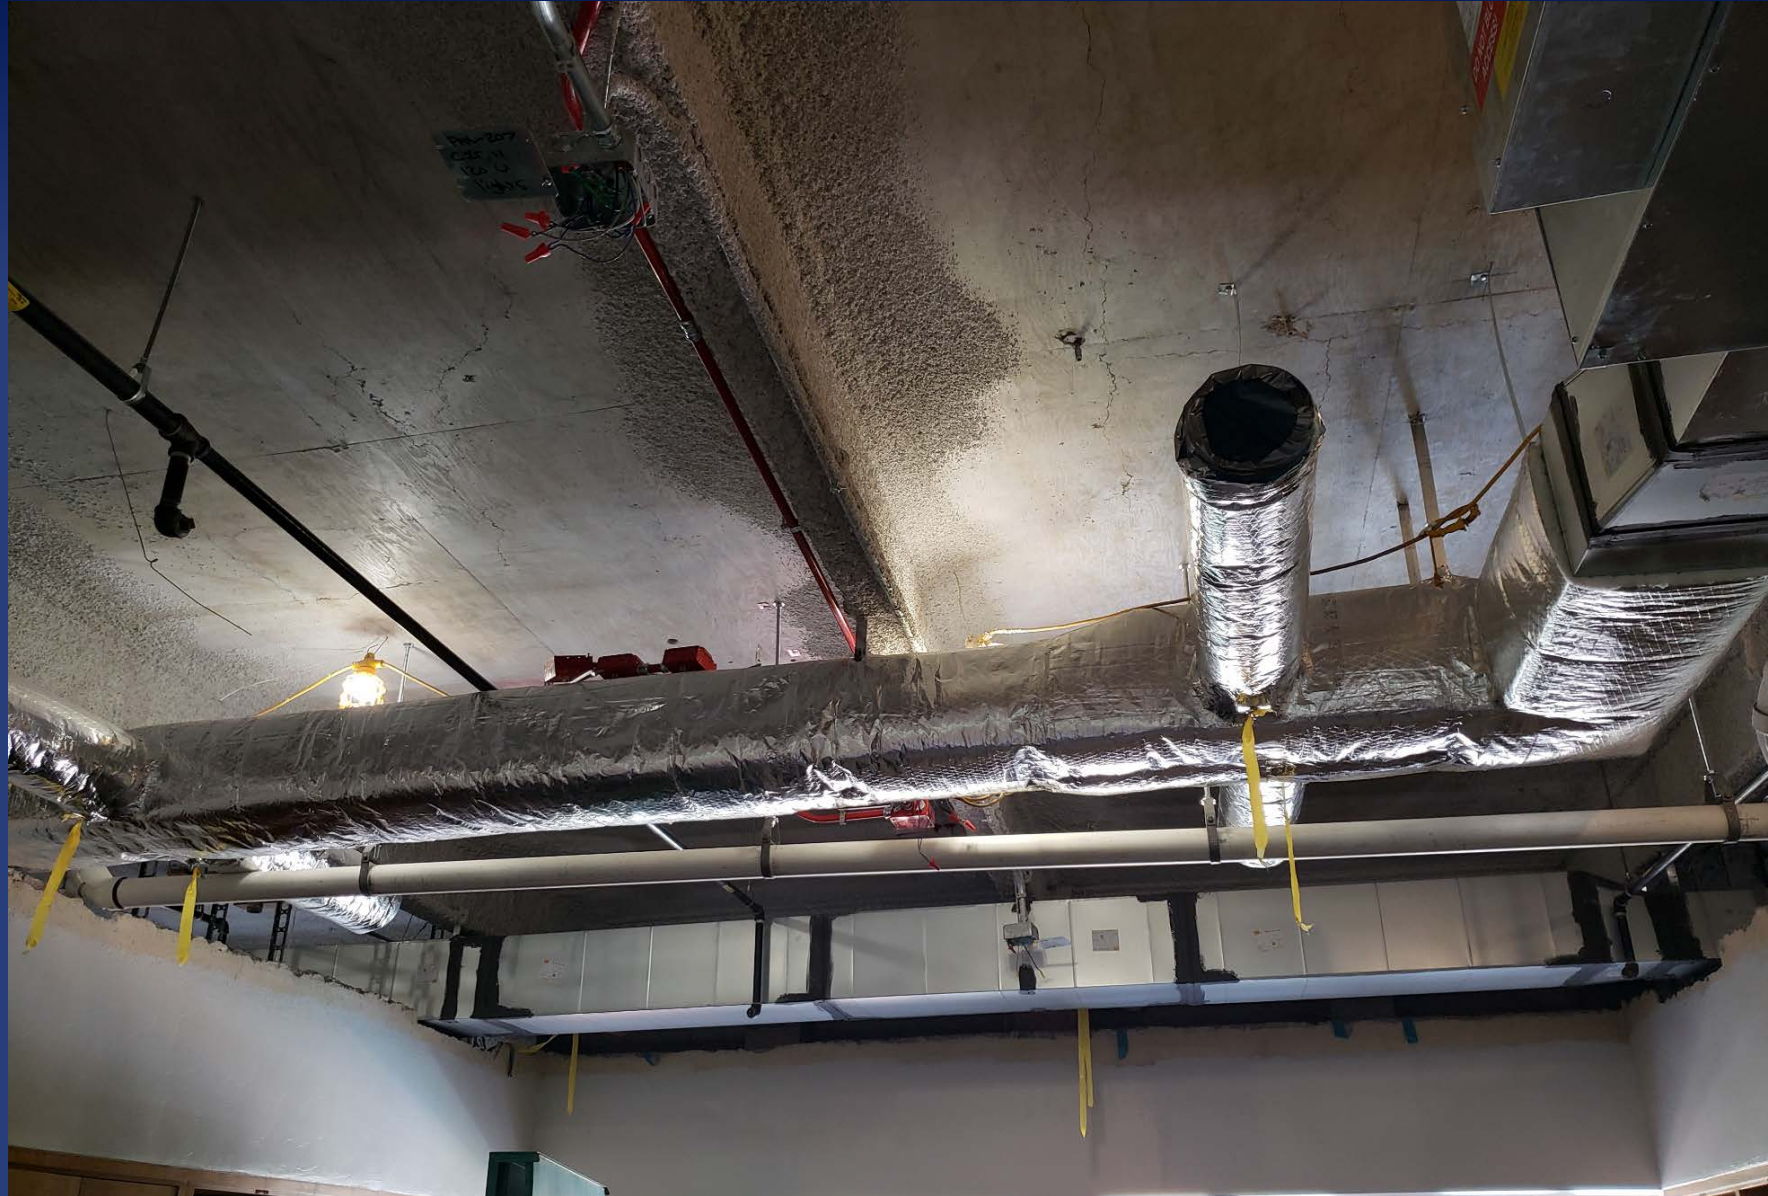
ABOVE THE CEILING AFTER

New Ductwork
New Terminal Boxes
New Digital Controls
New air terminals

New waste system
New Laboratory Piping

New Electrical Feeder
New Panelboards
New Lighting

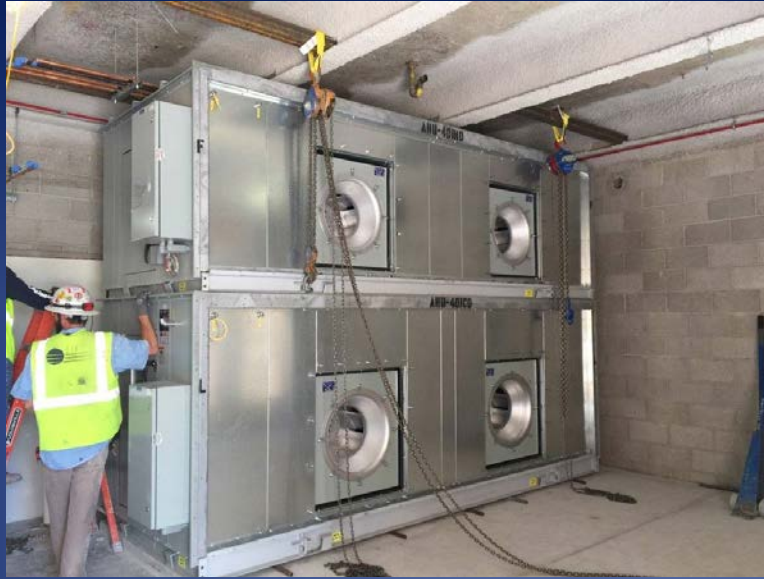
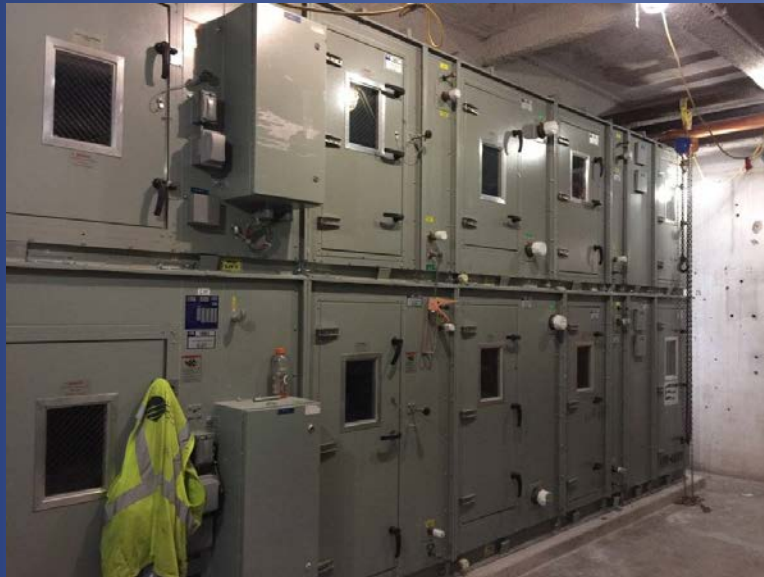
AHU BEFORE AND AFTER

Remove 50 year old dual
deck air handlers

Install new single duct units-
Shipping splits to fit through
building openings
Assemble in place
Air leakage test

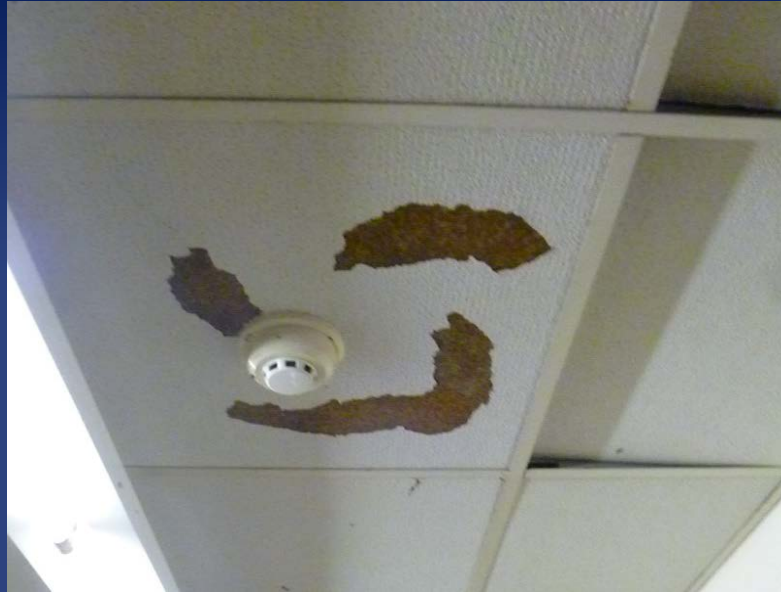
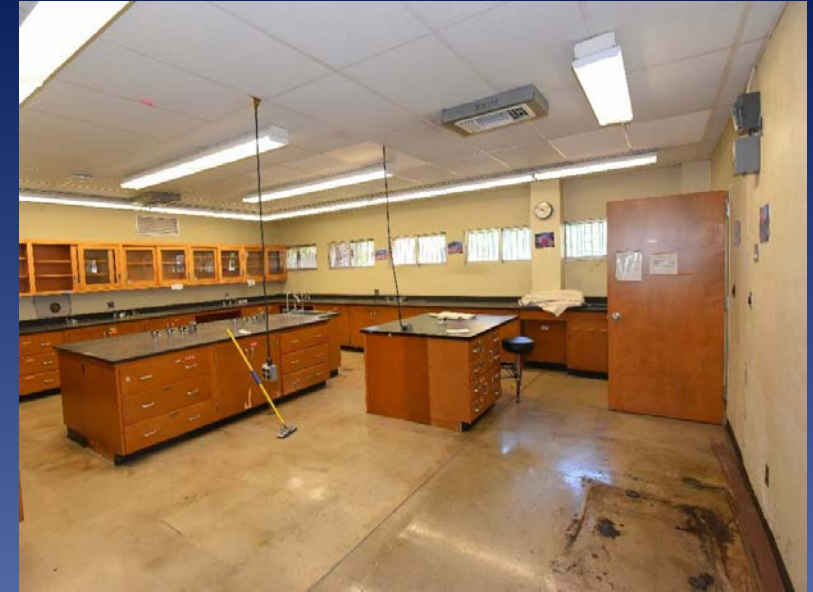
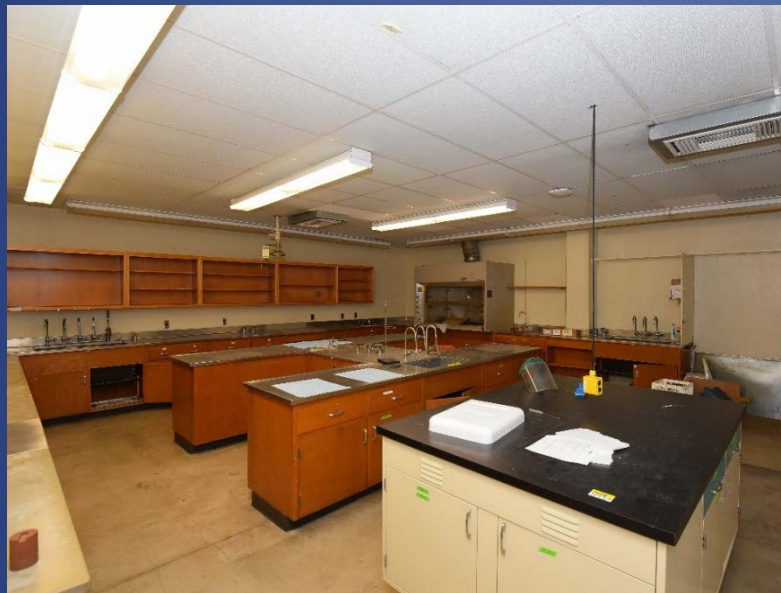
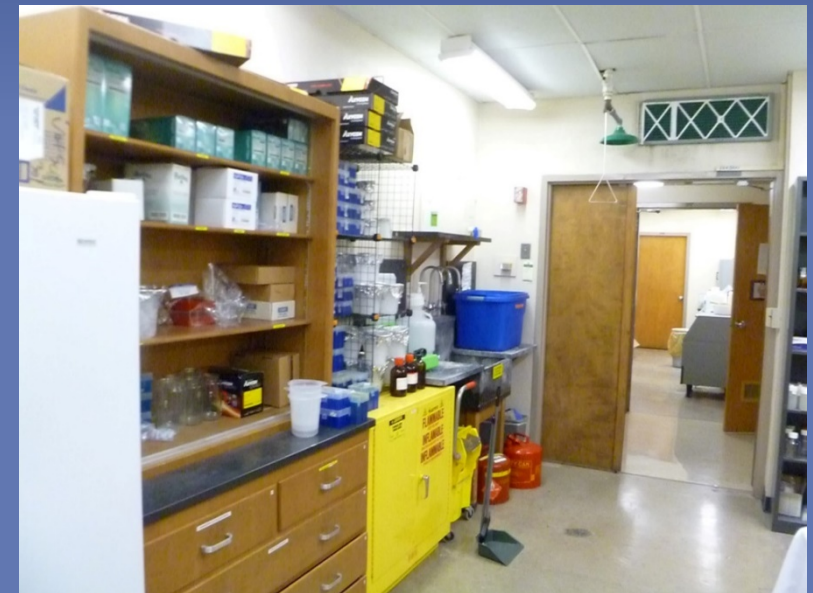
BELOW CEILING BEFORE

Failing ceilings
Poor lighting
Cracked flooring
Moldy wooden
cabinets

Actual Occupancy
Utilization At 50%

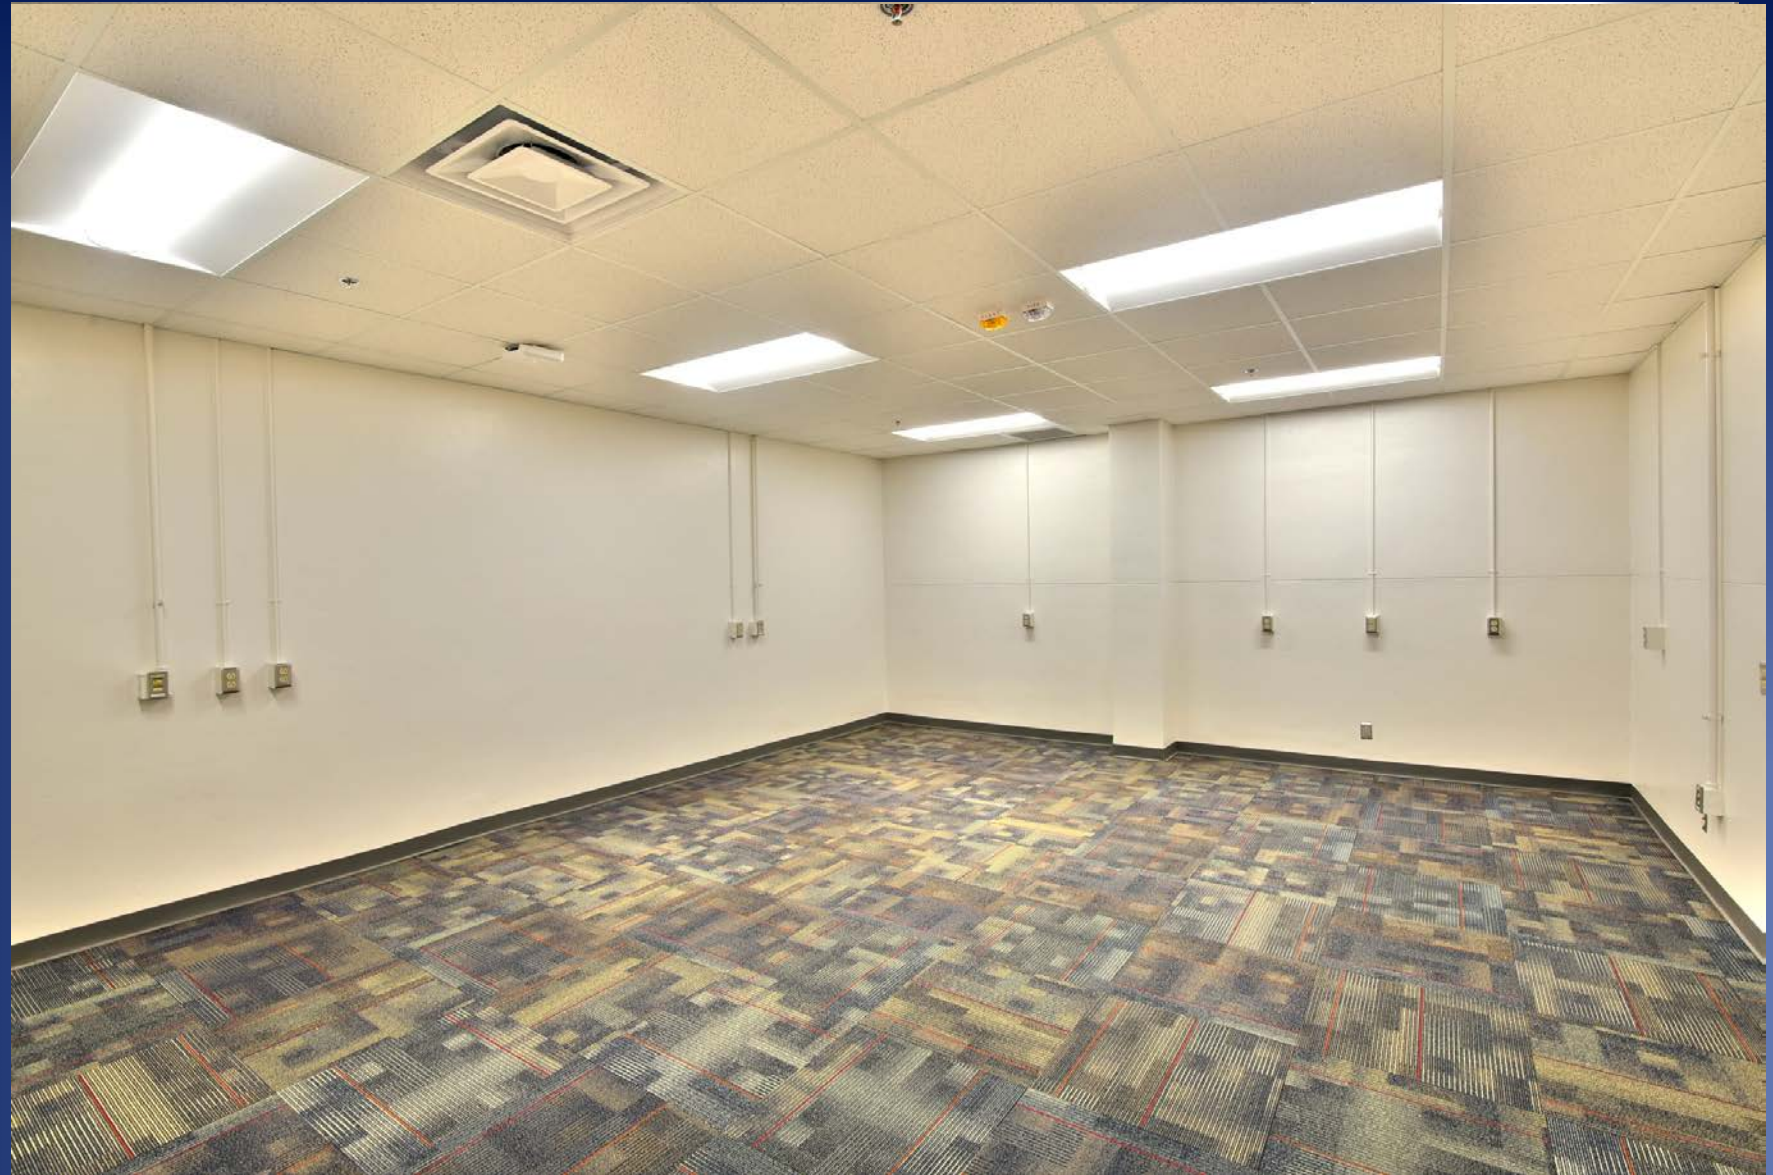
BELOW CEILING AFTER

New Finishes
New lighting
New Flooring
New Casework

Actual Occupancy
Utilization At 100%
